CIA IMAGERY ANALYSIS DIVISION

PIR 75053

CHAN-CHIANG (FT. BAYARD) PHOSPHATE FERTILIZER PLANT CHINA

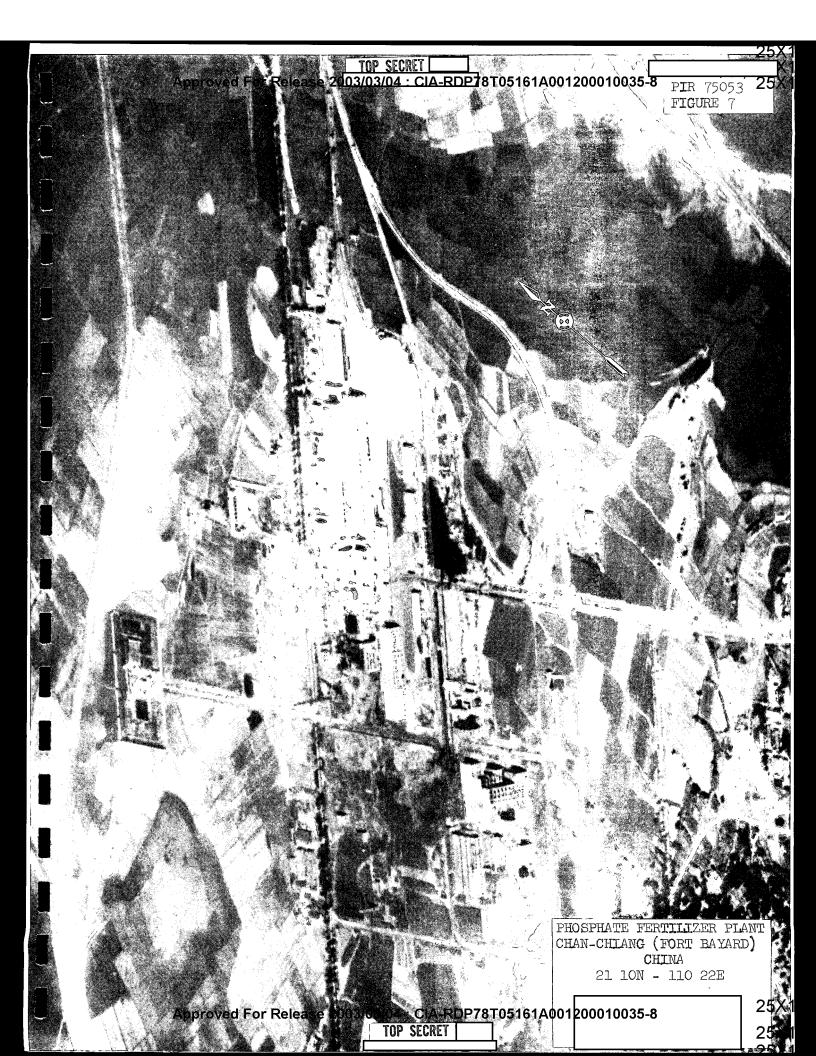
The following list of areas and plant facilities are keyed to the annotated photo enlargement, Figure 6:

AREA 1 Fertilizer Production

- a. Ore receiving point
- b. Ore processing and storage
- bl. Probable fertilizer storage
 - c. Crushing building
- d. Mixing section and possible phosphoric acid production section
- e. Den and curing building
- Probable by-products processing and possible phosphoric acid processing building
- g. Final processing and fertilizer warehouse

Approved For Release 2000000000000000000000000000000000000
	TOT SECRET
	CIA IMAGERY ANALYSIS DIVISION PIR '75053
25X1	25X1
	AREA 2 Contact Sulfuric Acid Production

h. Waste disposal i. Ore processing and storage (pyrite) j. Roaster section k. Tower and converter section l. Cooling coils m. Acid storage n. Air intake
	AREA 3 - Unidentified Chemical Plant Under Construction
	AREA 4 - Water Purification Facility
	AREA 5 - Open Storage Area
25X1 25X1	Photography showed the Chan-chiang phosphate fertilizer plant to be in early to mid-stage of construction. The only buildings completed at that time were the ore storage/fertilizer warehouse and several of the support buildings. By Figure 3, construction on the den and curing building, the final processing and fertilizer warehouse, and additional support buildings had been completed. Also, construction on the sulfuric acid plant was estimated to be in mid-stage. Photo coverage indicated that all of the major components of the plant were completed and operational. Only minor construction activity on support type buildings was

25X1	being carried on, Figure 4 all construction appeared complete, and a shed-type building at the phosphate ore receiving point had been removed, Figures 5 and 7. Small scale and obliquity precluded determination of the production activity at this time. Coverage clearly shows the plant to be complete and operating at a high level of production, Figure 6.
	25V4
	25X1
	25X1
